SHORE EROSION STUDY

SHORELINE EROSION AND BLUFF STABILITY

ALONG LAKE MICHIGAN AND LAKE SUPERIOR

SHORELINES OF WISCONSIN

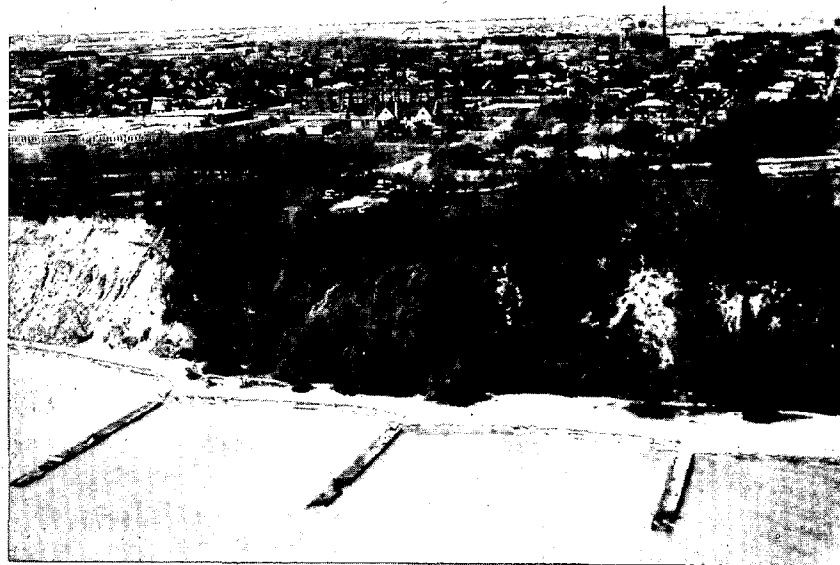
Figure 9. Oblique aerial photograph of the effect of a groin on shoreline erosion. Note the wide beach between the groins and the narrow beach and actively eroding bluff to the left (south) of the groins. Location T. 6 N., R. 22 E., Section 25, Reach 8, Milwaukee County (oblique R-20,23).

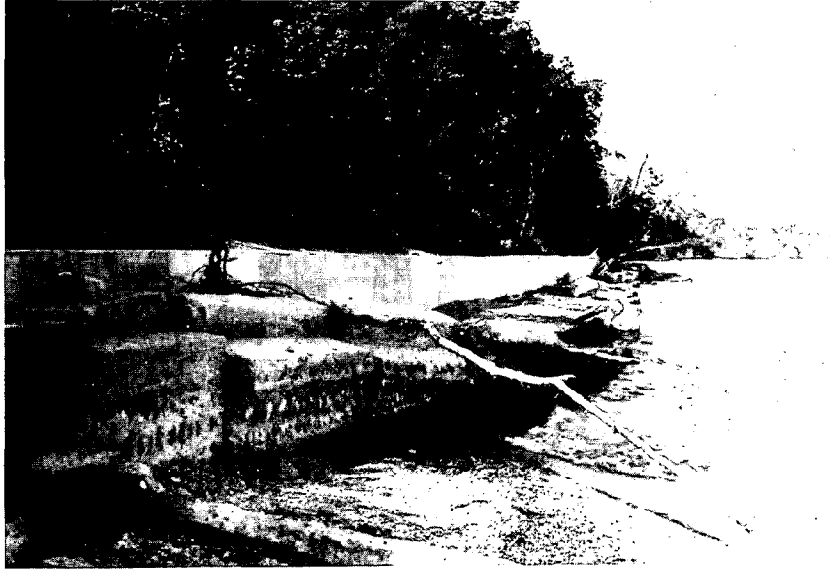
Figure 10. Photograph of seawall showing old collapsed seawall in foreground and new seawall in background. Both walls are being overtopped by waves (note gravels above wall and erosion behind wall in center of photograph). Location is T. 9 N., R. 22 E., Section 20, Milwaukee County (structure 20.7)

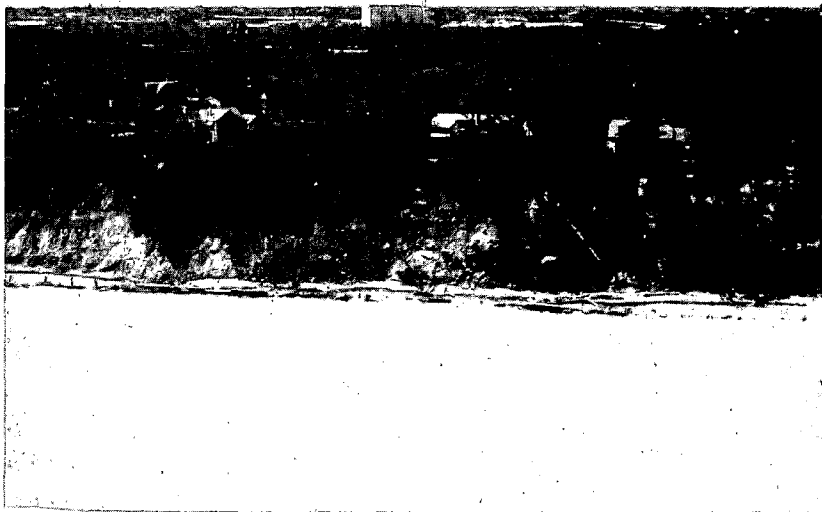
Figure 11. Oblique aerial photograph of collapsed seawalls. Note the amount of erosion that has taken place since the seawalls were built. Location is T. 8 N., R. 22 E., Section 33, Reach 10, Milwaukee County (oblique R-17, 20).

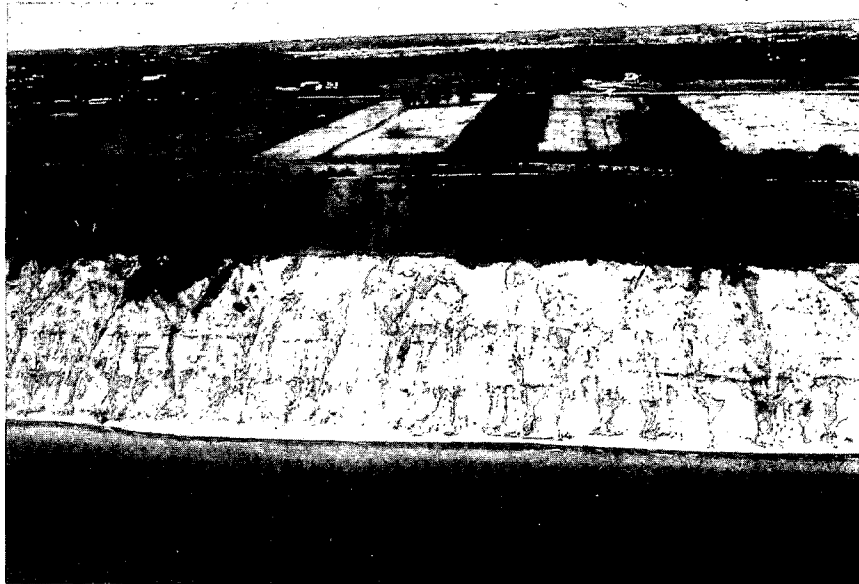
Figure 12. Oblique aerial photograph showing bluff where shallow slides and some flows are the common mode of failure. Note the almost complete lack of vegetation on the slope. Location is T. 10 N., R. 22 E., Section 3, Reach 13, Ozaukee County (R-13,8).

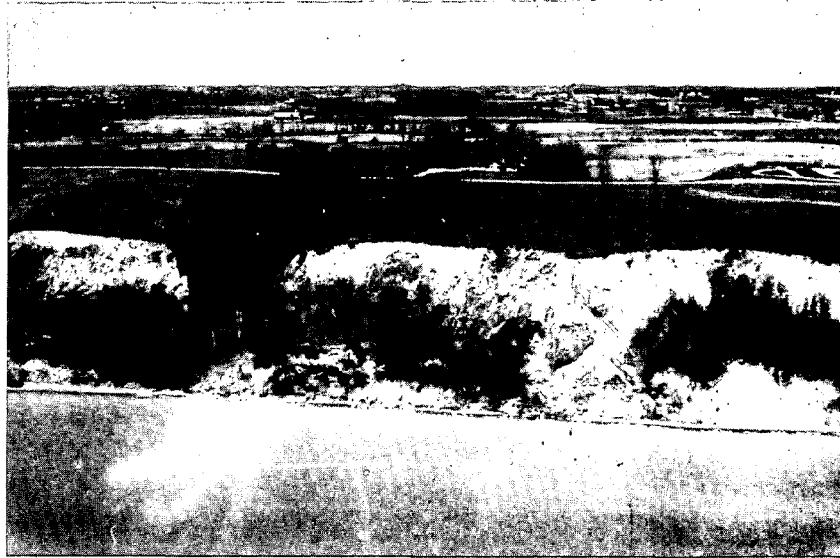
Figure 13. Oblique aerial photograph showing relatively large slump blocks. Note the scalloped nature of the bluff top produced by this mode of failure. In right center of the photograph is a flow which took place after failure by slumping. Location is T. 10 N., R. 22 E., Section 21, Reach 13, Ozaukee County (R-13, 25).

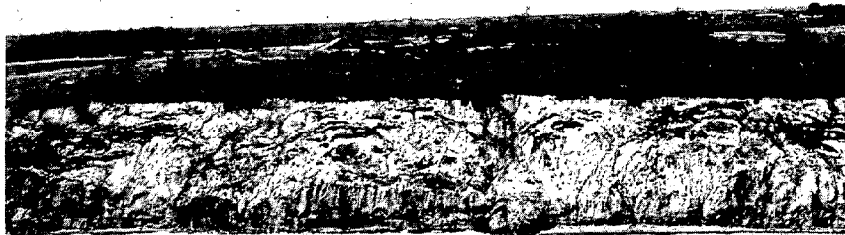
Figure 14. Oblique aerial photograph of bluff showing numerous closely spaced failure plains. These failures may be fairly deep-seated. But failure is along numerous plains as opposed to along a single plain as in Figure 15. Location is T. 5 N., R. 22 E., Section 25, Reach 13, Milwaukee County (R-22,12).

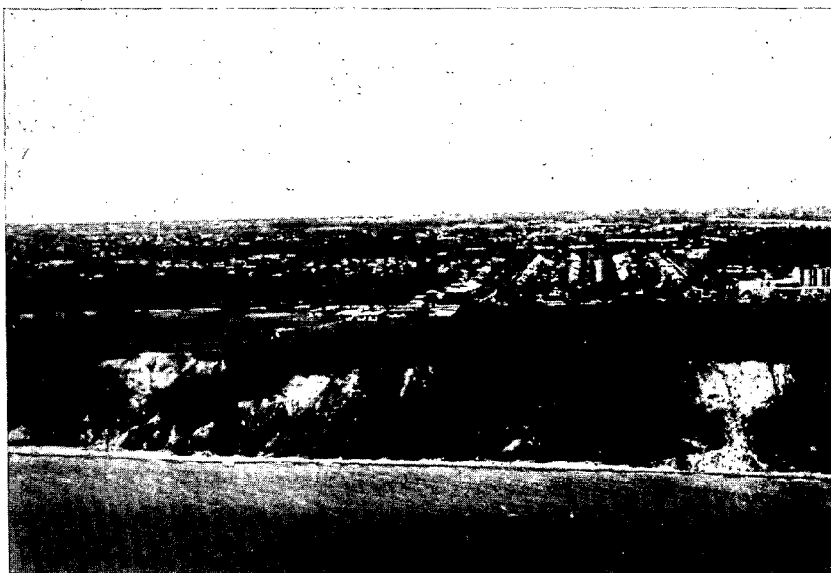
Figure 15. Oblique aerial photograph showing failure taking place because of groundwater sapping beneath sand. Water enters the groundwater system through sand which is the surface material here and flows outward along fine-grained material. Sand is then carried by flows to the beach as groundwater discharges along the edge of the bluff. Location is T. 6 N., R. 22 E., Section 36, Reach 8, Milwaukee County (oblique R-20, 34).

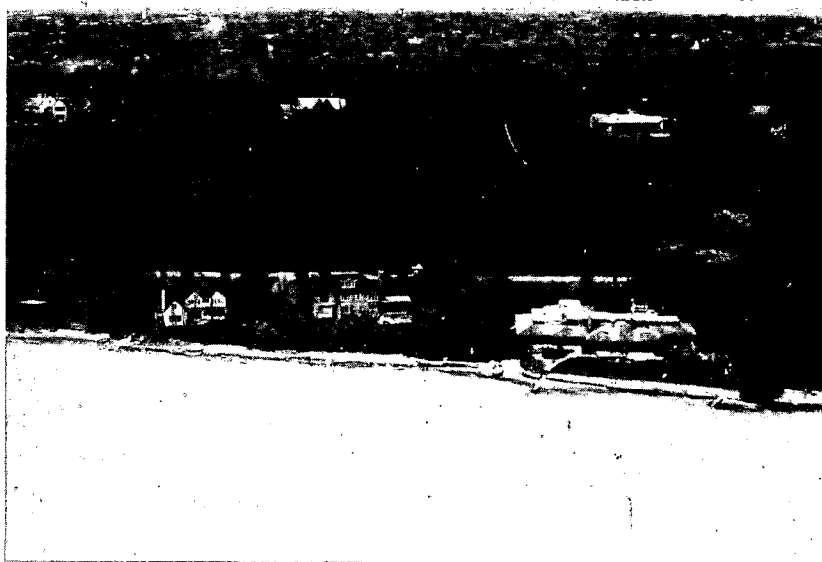
Figure 16. Oblique aerial photograph of wooded bluff behind natural terrace. Most of the terrace edge is protected from erosion by revetments. The bluff behind the terrace is stable. Location is T. 8 N., R. 22 E., Section 21, Reach 10, Milwaukee County (oblique R-16,27).

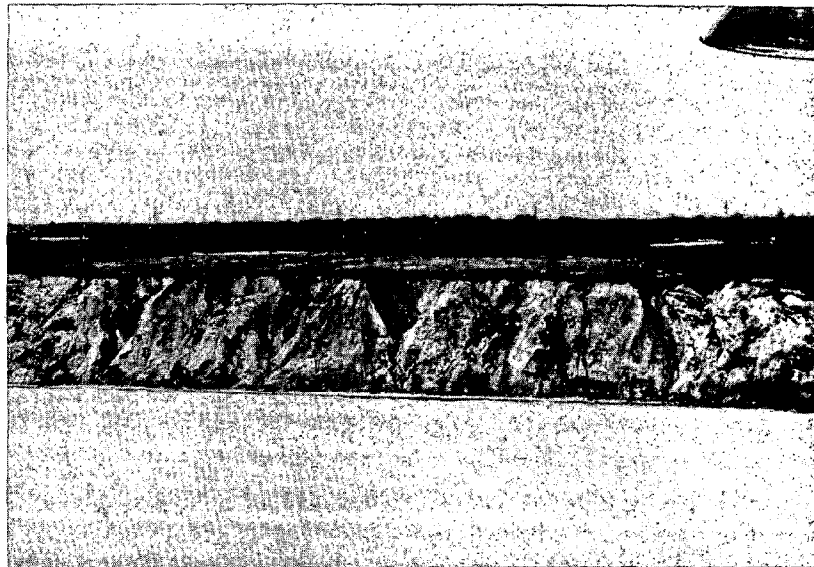
Figure 34. Oblique aerial photograph of the bluff in the southern part of Reach 7. Note the scalloped nature of the bluff top because of shallow slumps in the upper part of the bluff. Location is T.5N., R.22E., Section 25, Reach 7, Milwaukee County (oblique R-22, 13).

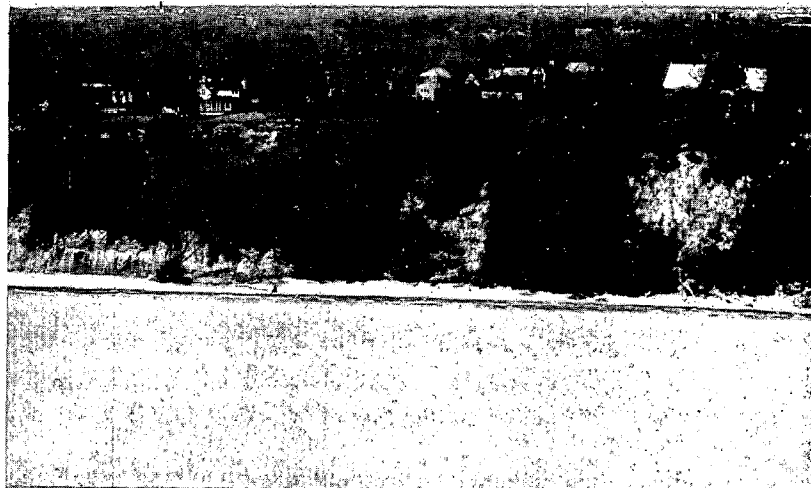
Figure 38. Oblique aerial photograph showing areas where rapid toe erosion is taking place and failure is primarily by shallow slides. Location is T.8N., R.22E., Sections 33 and 34, Reach 10, Milwaukee County (oblique R-17, 13).

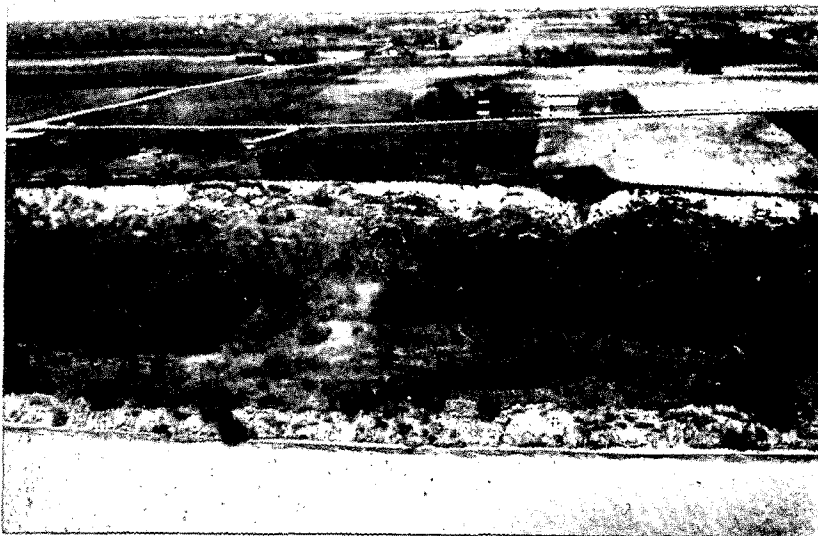
Figure 44. Oblique aerial photograph showing very large slump blocks in Reach 13. Much of the slump block is vegetated and is presently being eroded at its toe. Location is T.10N., R.22E., Section 16, Reach 13, Ozaukee County (oblique R-13, 20A).

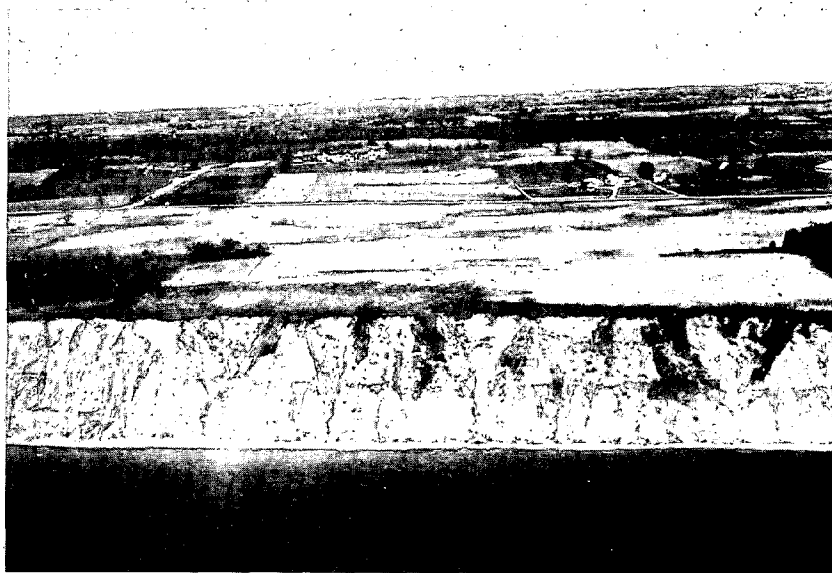
Figure 45. Oblique aerial photograph showing steep nearly un-vegetated slope where most failure is taking place by shallow translational slides and flow. Some small slumps occur near the top of the bluff. Location is T.10N., R.22E., Section 3, Reach 13, Ozaukee County (oblique R-12, 33).

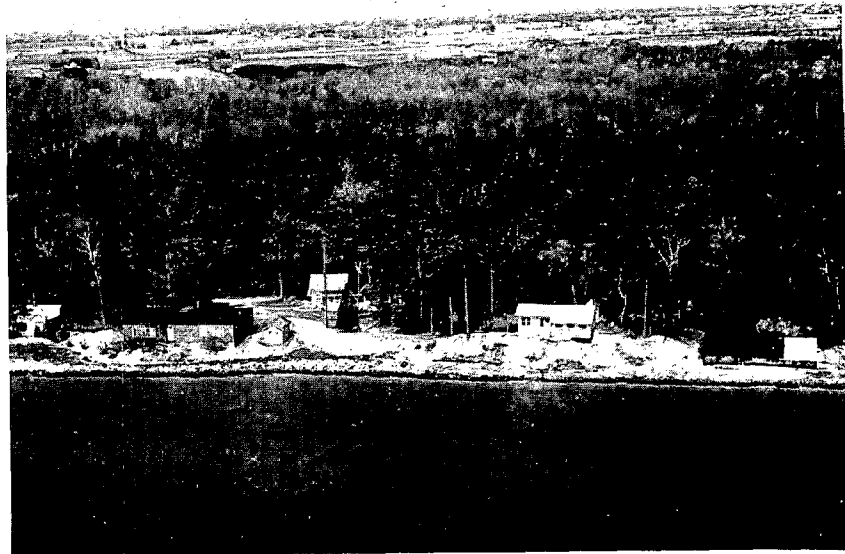
Figure 58. Oblique aerial photograph showing the nature of the shoreline in the northern portion of Reach 18B. Storm waves have gone over many of the low revetments found in this area resulting in considerable erosion and some damage to homes. (oblique 6,33)

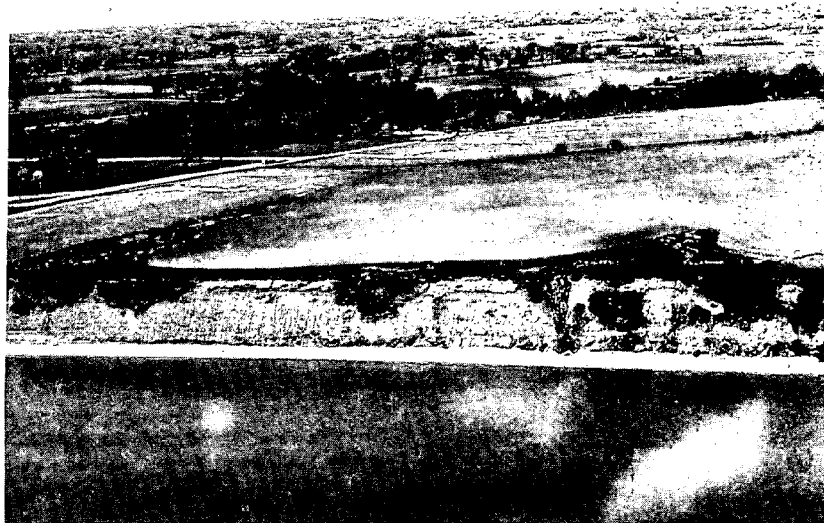
Figure 65. Oblique aerial photograph of a typical shoreline segment in north and central Reach 21. The bluff is composed entirely of lacustrine sediments with silty clay at the base grading through clayey silt to sand at the bluff top. Slope failure here is primarily through undercutting and soil fall with some high angle slumping. (oblique 52,14)

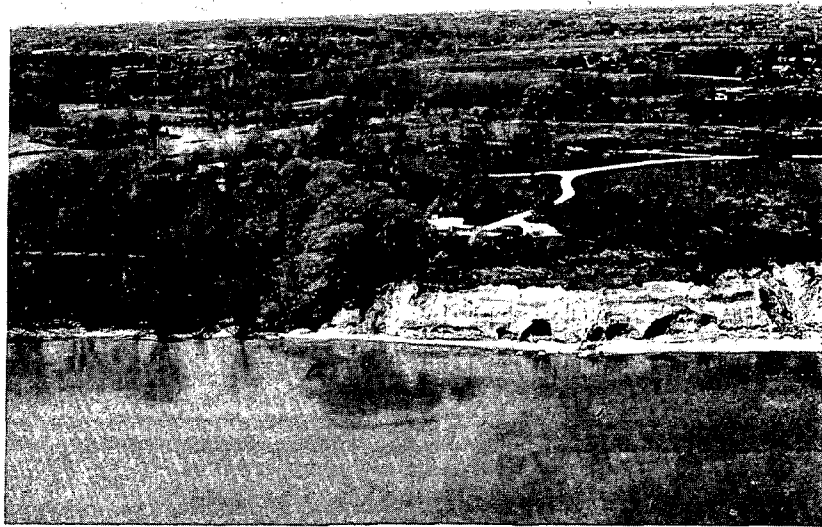
Figure 66. Oblique aerial photograph at the northern valley wall of the Pigeon River in Reach 21. Erosion of a massive silt along the base of the bluff has created a series of "sea caves." (oblique 52,22)

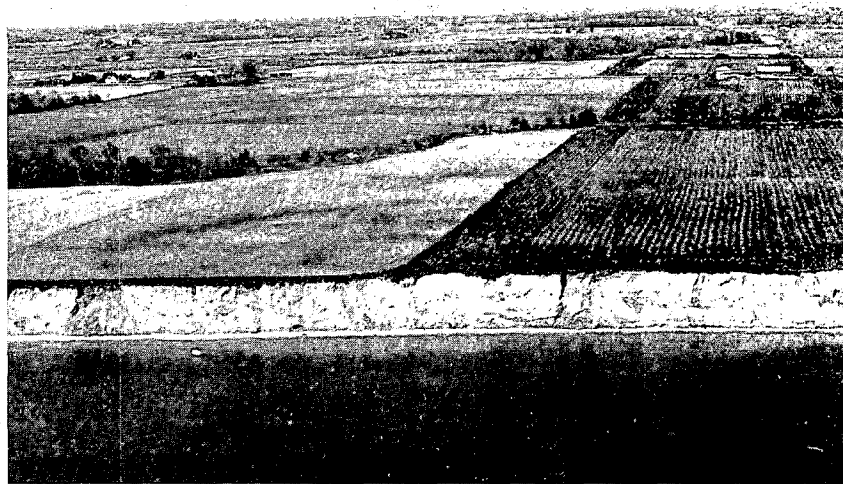
Figure 68. Oblique aerial photograph showing steep, unvegetated bluff typical of the southern portions of Reach 22.
(oblique 51,35)
